SUBJECT: Canadian Radium and Uranium Site/ Screening Site Inspection

DECONTAMINATION AND DEMOLITION OF THE
CANADIAN RADIUM & URANIUM CORPORATION FACILITY

69 Kisco Avenue
Mount Kisco, New York

FINAL REPORT
for the
MOUNT KISCO URBAN RENEWAL AGENCY
Municipal Building
Mount Kisco, New York

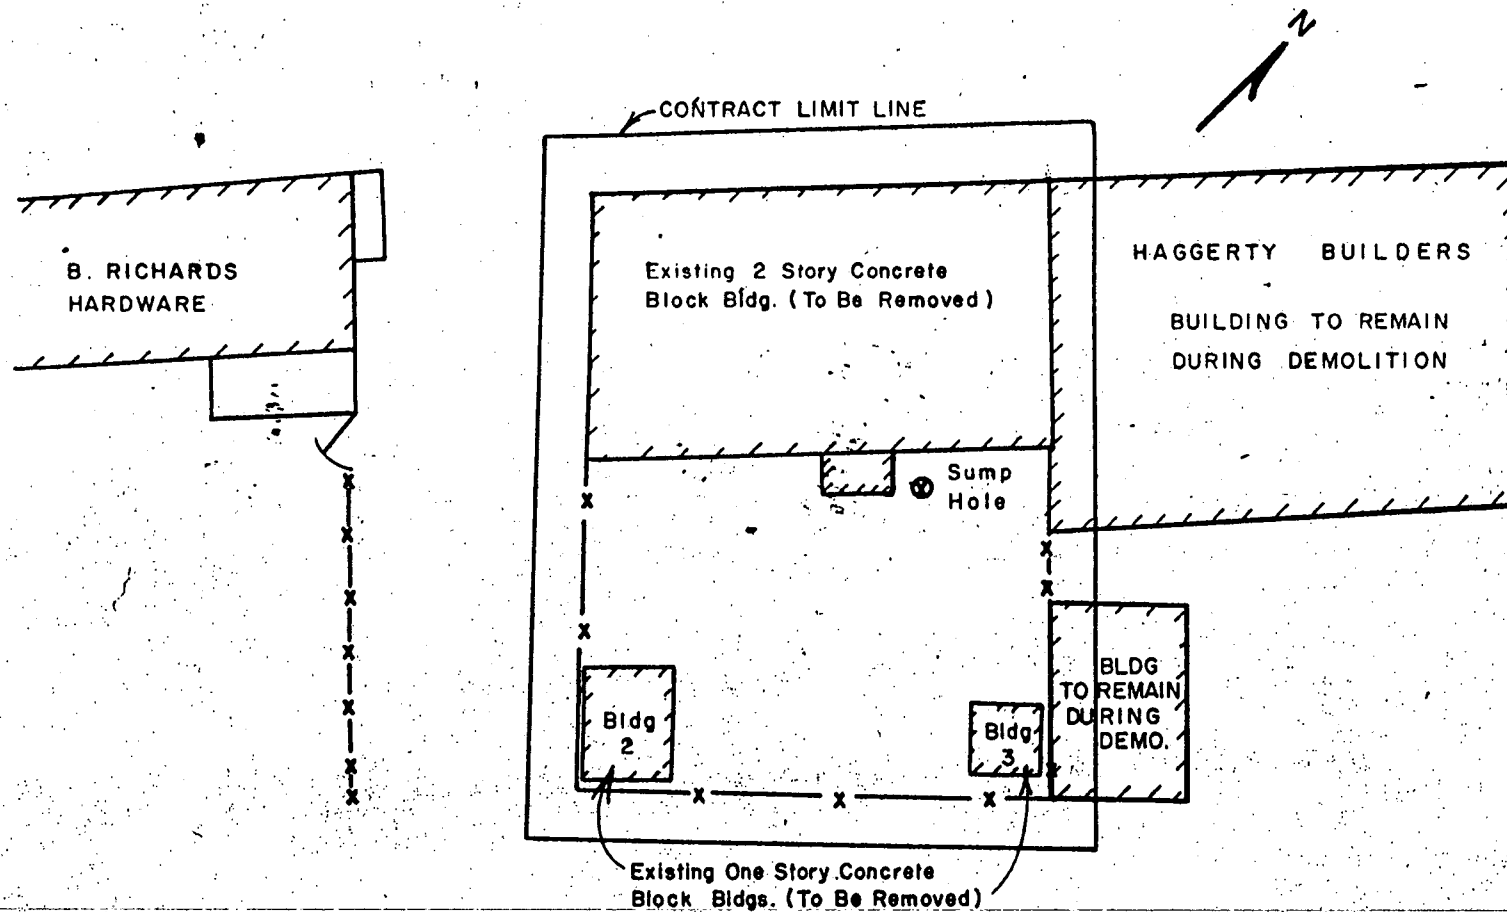
FIGURE 1. CANADIAN RADIUM AND URANIUM FACILITY SITE PLAN

Figure 1 provides a general site-plan of buildings, grounds and surrounding structures. Figure 2 shows the results of the initial survey of the second floor of the main building. All readings were taken at one centimeter above the floor. The entire floor surface was monitored at one meter intervals by "walking" the area. On this "scan" one spot at ~ 4 mR/hr and one at ~ 2 mR/hr were found. These were removed into a high level waste drum. Readings were then taken at ten foot intervals across the back section of the building for record purposes. These were all below one mR/hr except for a 60 sq ft area along the northeast wall party to the Haggerty Millwork building. The contamination in this area was found to be quite firmly fixed in paint and concrete. Rather than create a more serious dust

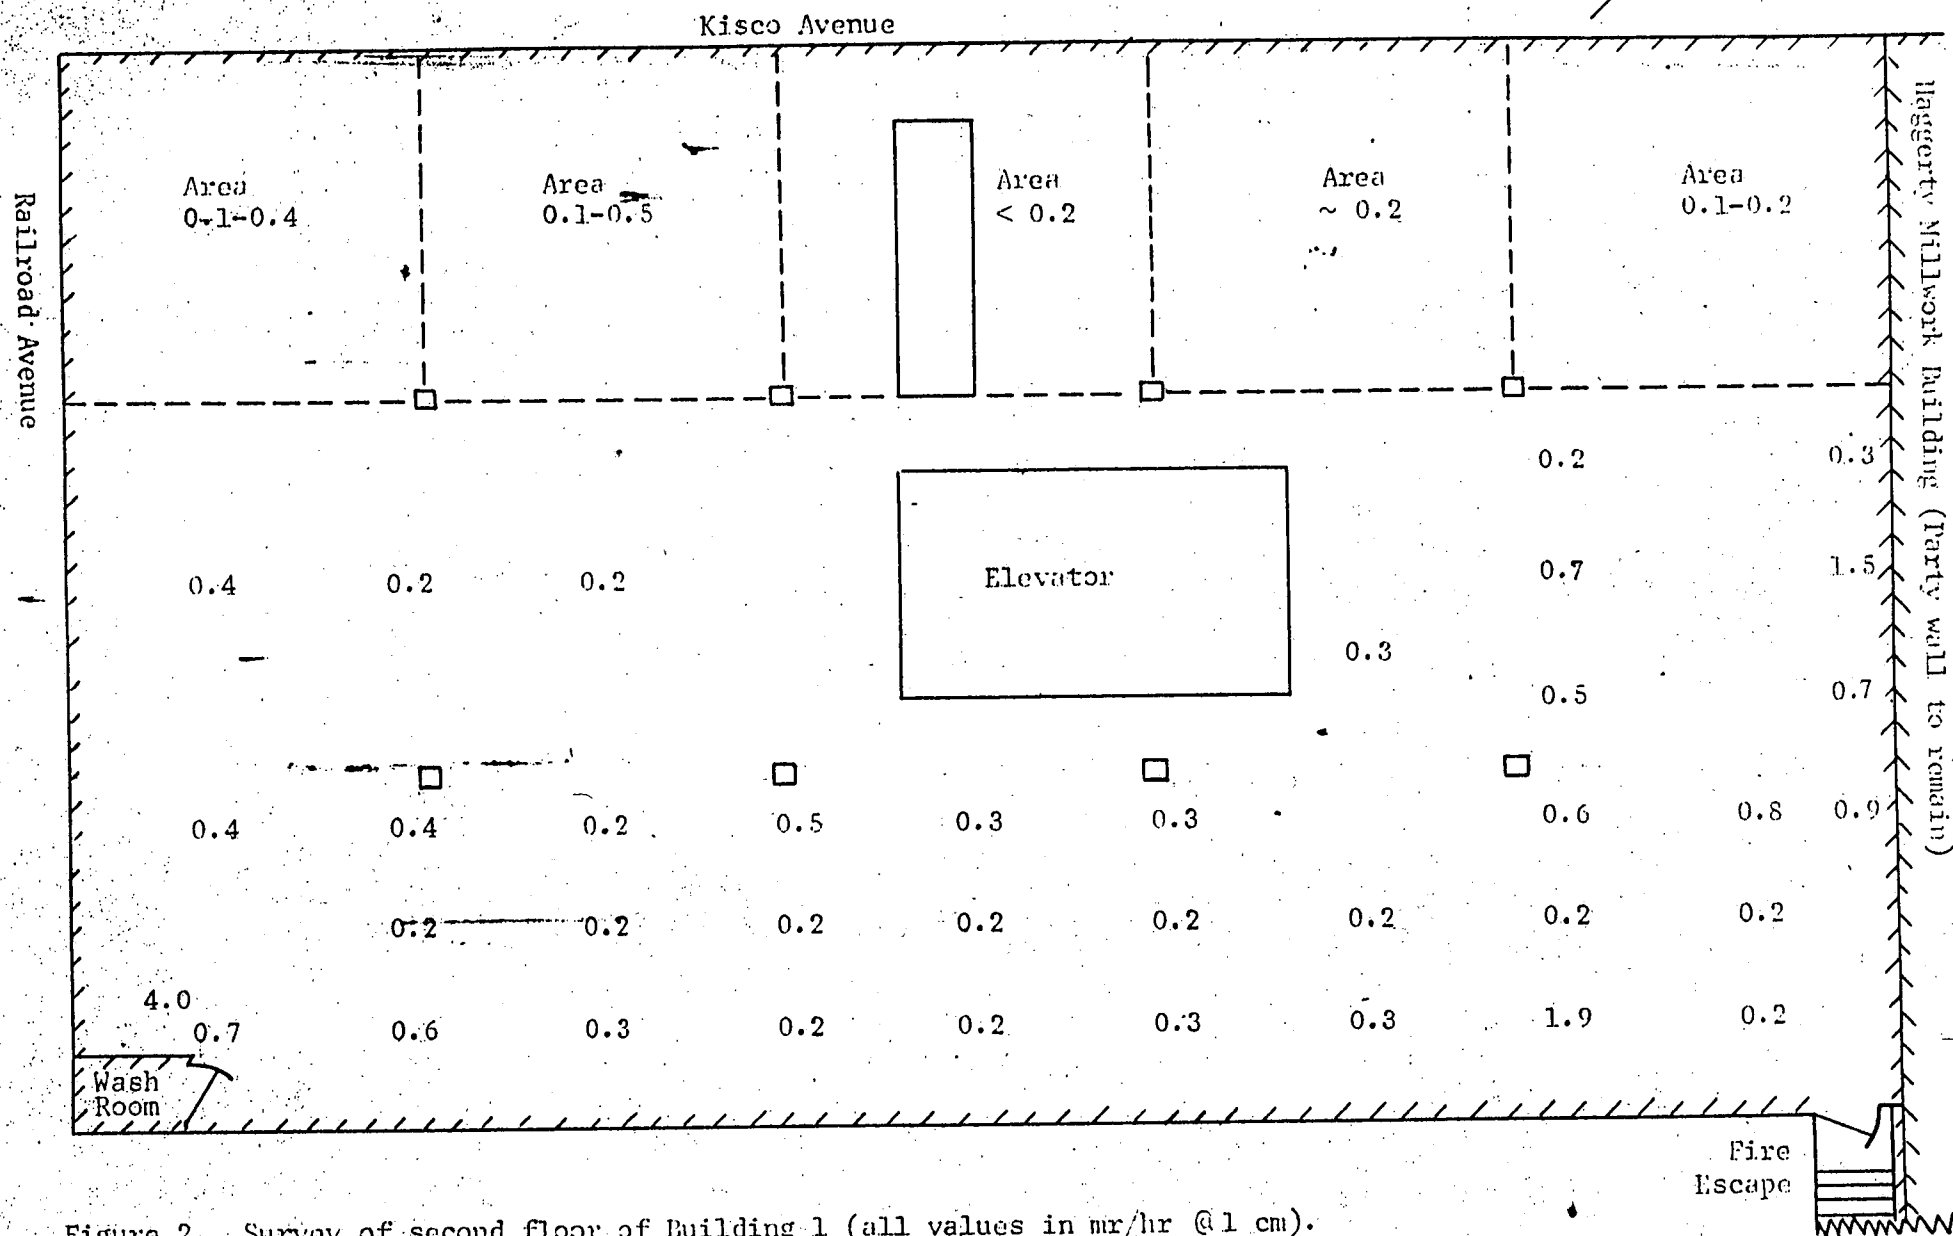
Figure 2. Survey of second floor of Building 1 (all values in mr/hr @ 1 cm).

problem it was decided to leave this activity fixed for demolition. This plan received the approbation of Messrs. Paul and Weber prior to start of demolition. The total amount of radium to be buried at Croton Point Dump was estimated from this survey to be ~ 3 mg.

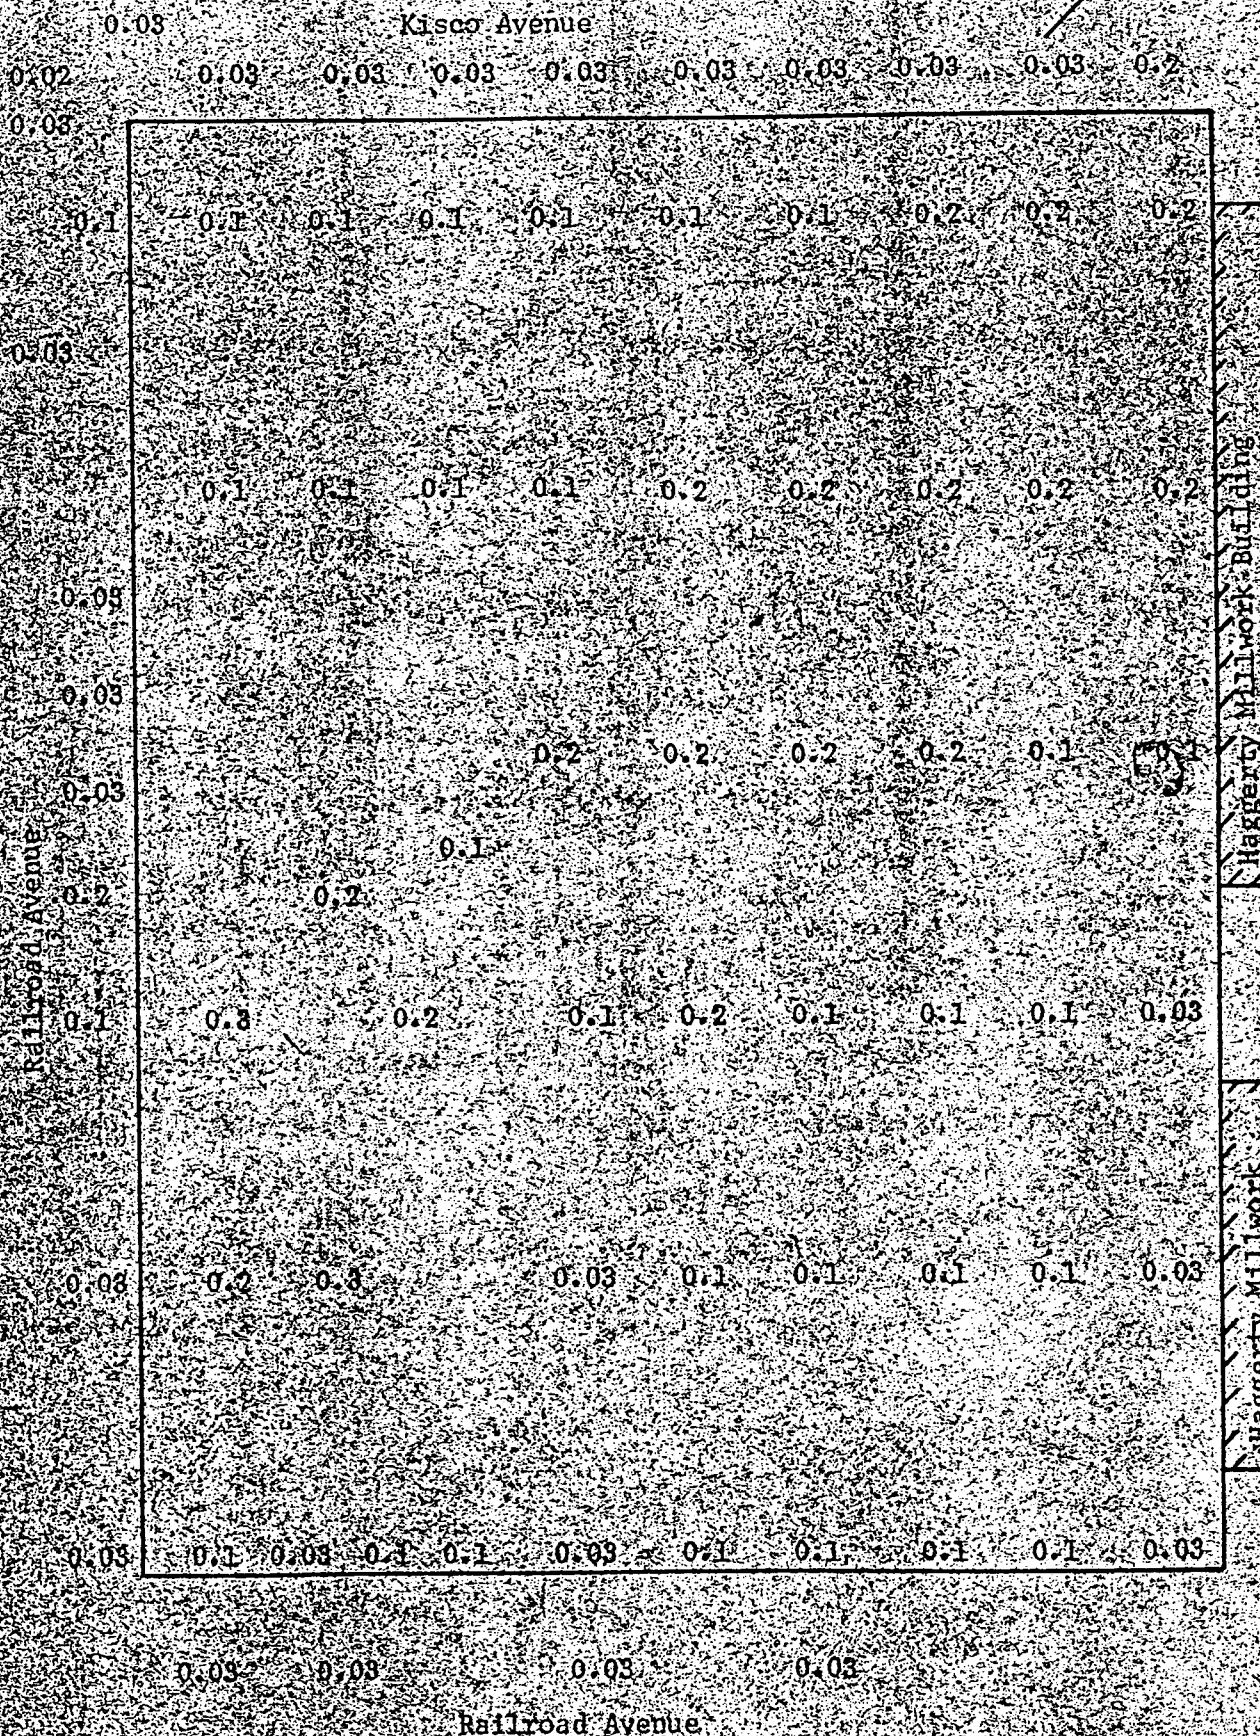
Figure 3. Survey of Canadian Radium site just prior to backfilling and grading (all values in mr/hr @ 1 cm).

On completion of demolition and burial of the building and scraping of the site and surrounding areas to required depths, the site was surveyed for final record (Figure 3). Two locations on the Haggerty Millwork wall were found to be above specifications. One was removed by chiseling out the masonry. The second appeared to be the tailings from a leaking waste drum which Can-Rad had apparently stored on the second floor fire escape. A streak of activity roughly 12 ft. x 1 ft. showed a contamination level of 1-2 mR/hr at 1 cm. Removal of these load-bearing blocks would have severely strained the integrity of the building creating a serious safety problem to the occupants. Since the contamination level was so low (< 0.1 mg Ra) that the interior of the wall was at background, the activity was sealed in with 1 to 2 inches of mortar. This coating of concrete reduced the external dose to levels permissible for release to the general public. Since this structure was to be demolished within a year, such disposition did not present any long term radiological hazard. Nor did it present a problem for future demolition since, as well as being a small amount, spread over a relatively large area, it was so firmly fixed into the pores of the concrete block that washing prior to coating resulted in no change in activity level. No further radiological health precautions need be considered for future demolition work on the site. At this point Messrs. Weber and Paul approved the start of the backfilling and grading.

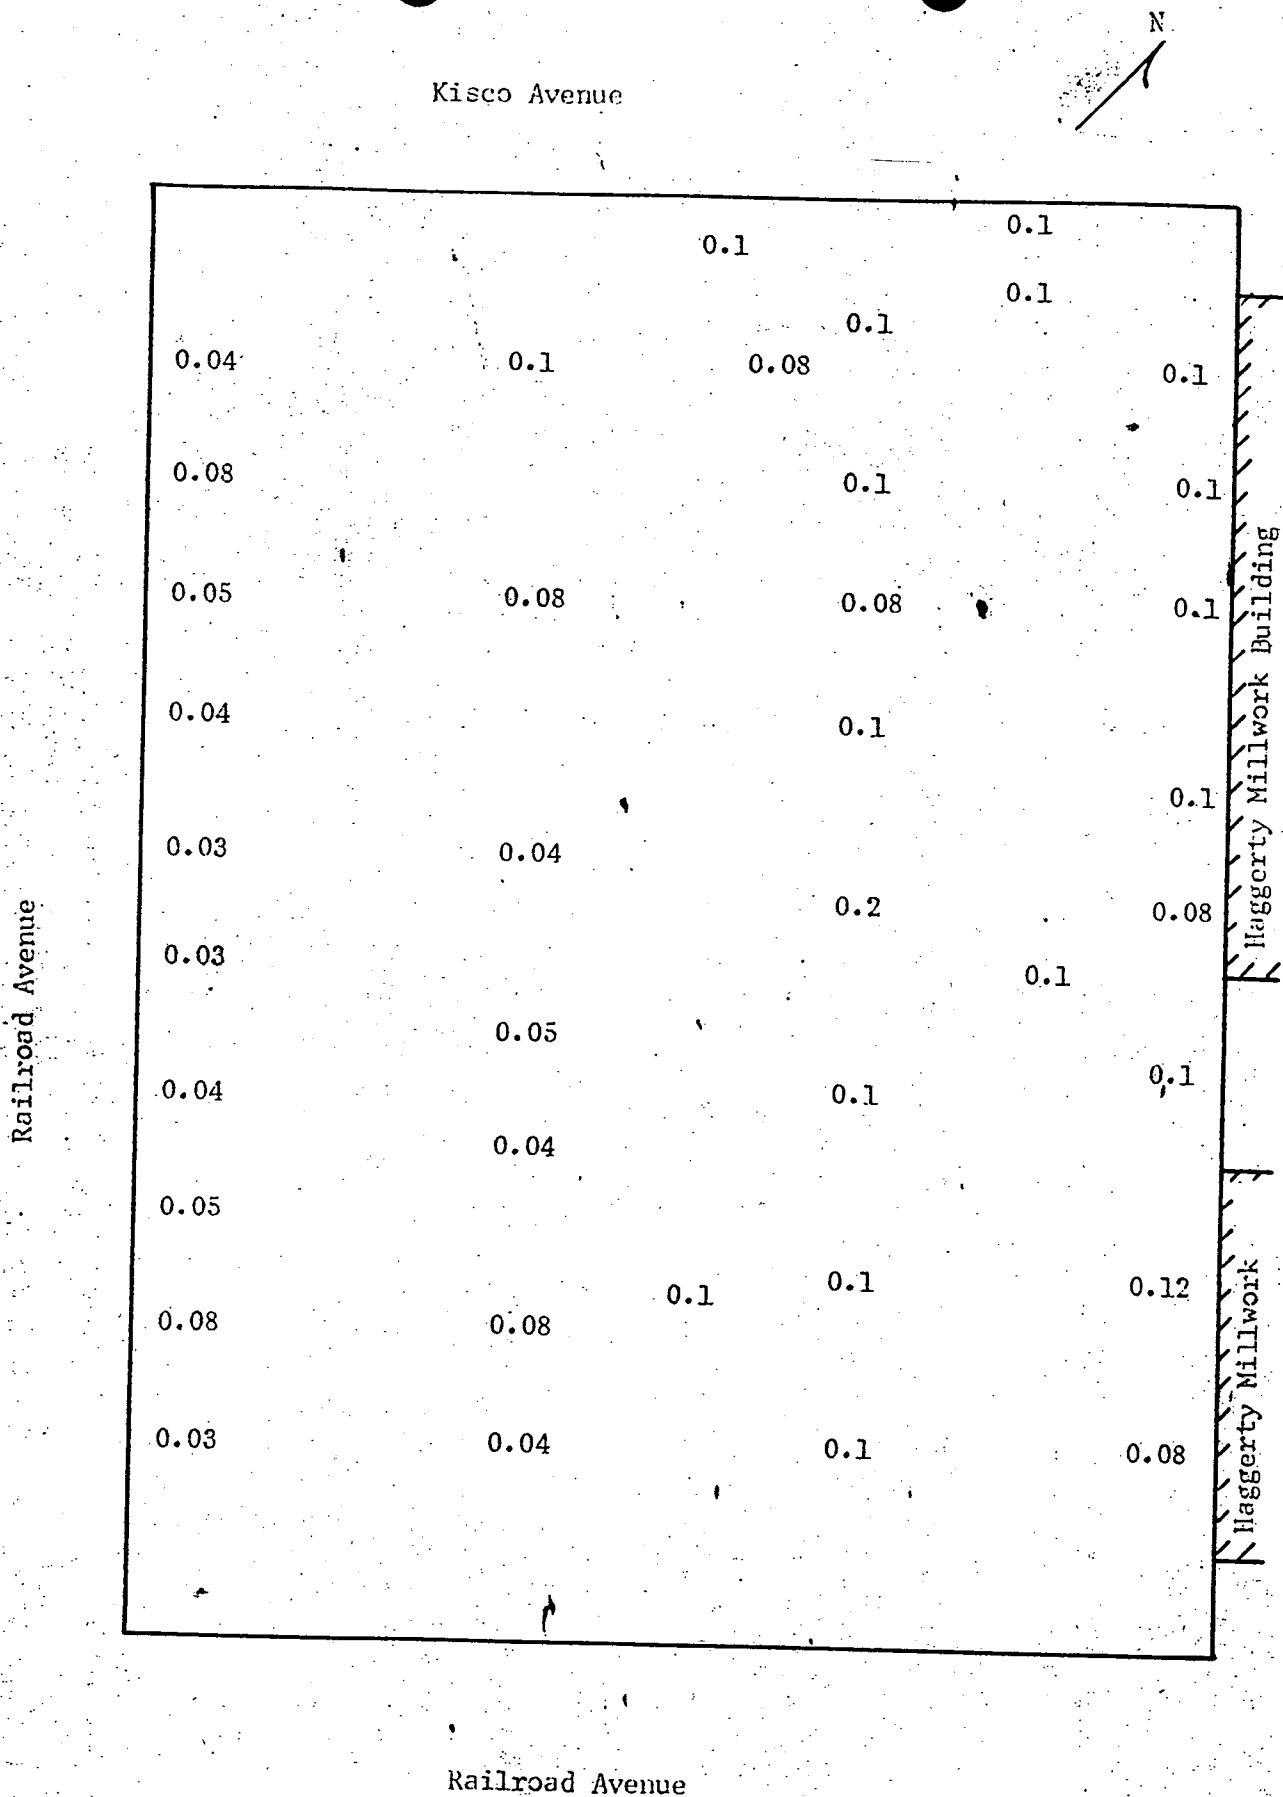
Figure 4. Survey of Canadian Radium site after backfilling and grading
(all values in mr/hr @ 1 cm).

On completion of backfilling and grading of the site, a final survey was made for record (Figure 4).
